Inspection Report

Property Address:
123 Main St
Spring Valley NY 10977

Capital Property Inspection Corp.

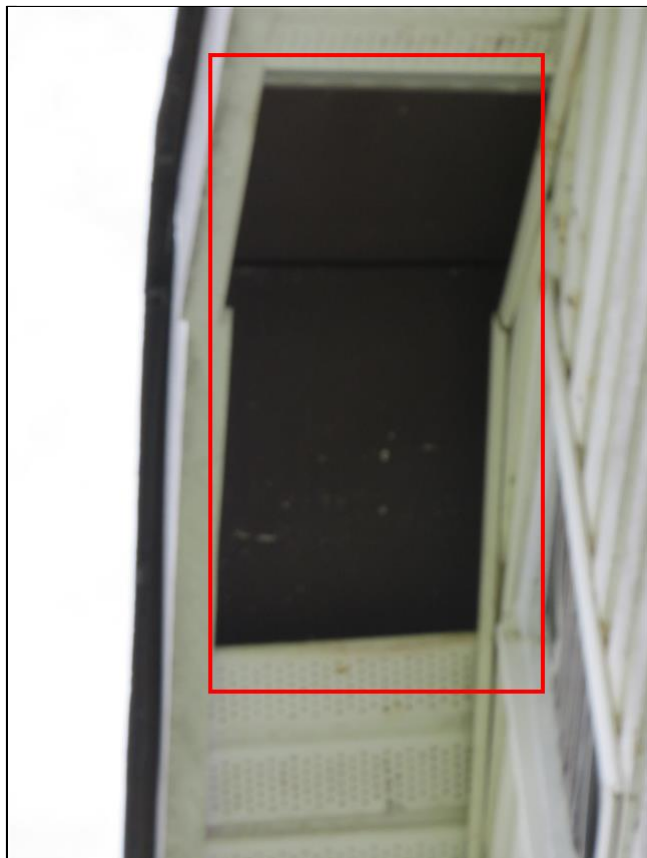
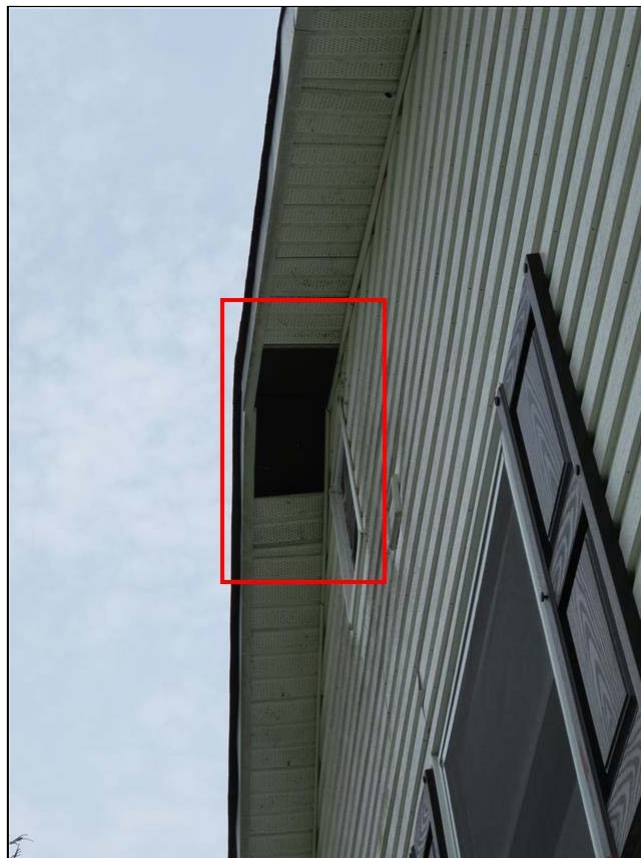
1.1 The side roof covering is loose and needs repair at the front, and right side (facing front). Deterioration may occur if not repaired. A qualified person should repair or replace as needed.

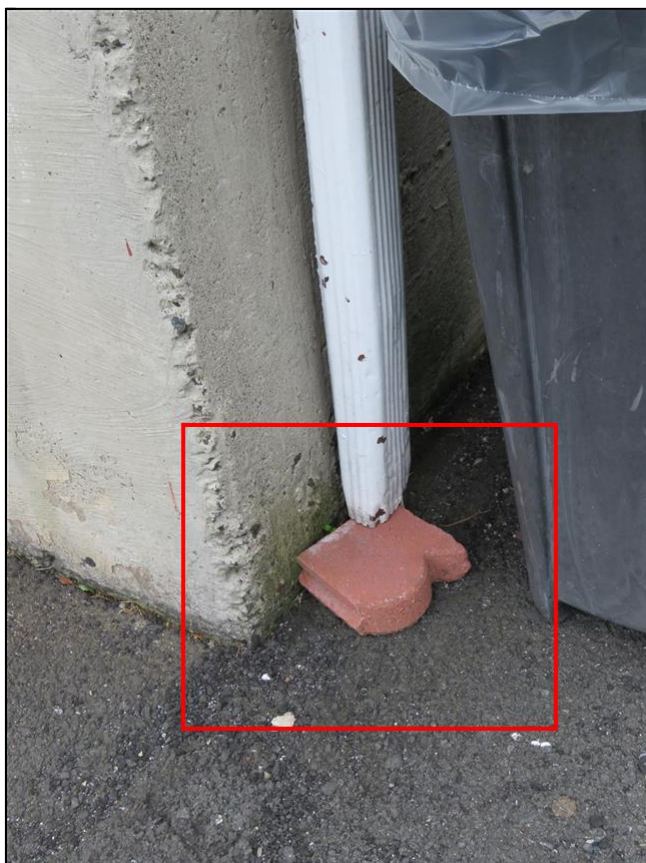
1.3

(2) The downspout needs an extension to carry water away from the home.

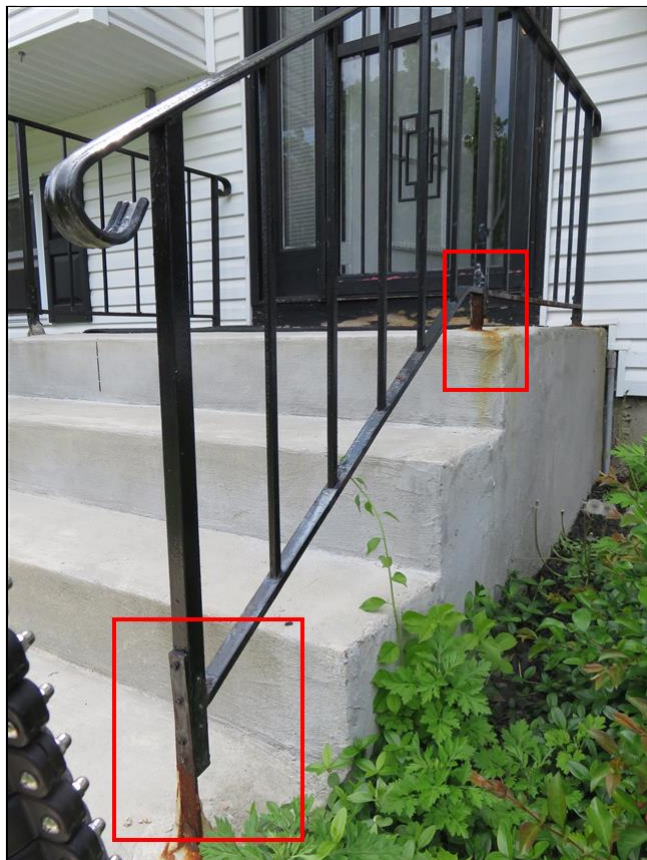
2.4 The hand/guard rail for the main entry is loose at the steps. This is a maintenance issue that can prevent further deterioration. A qualified contractor should repair or replace as needed.

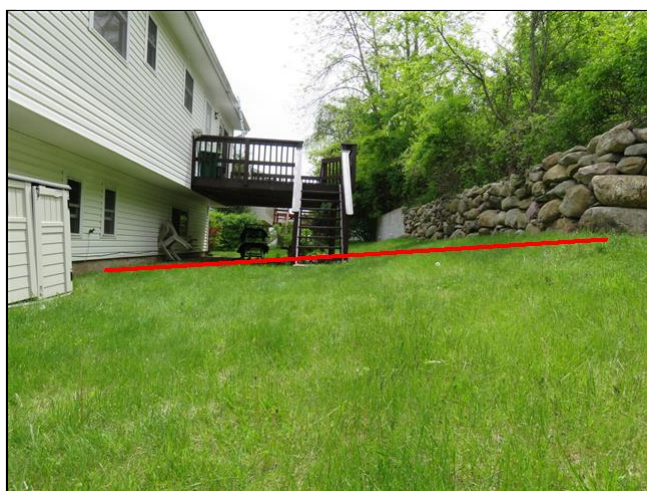
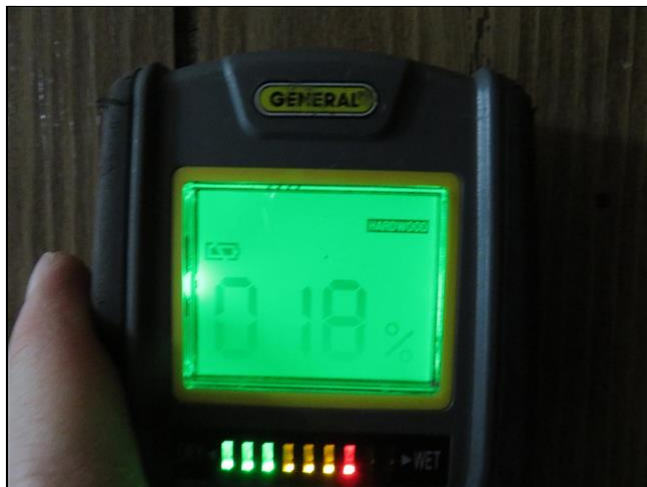
2.5 There is a negative slope towards the rear of home. This area does not appear to drain water away from home and needs landscaping and drainage corrected.

The moisture level on the wall behind the negative slope is elevated. A qualified licensed contractor should repair as needed.

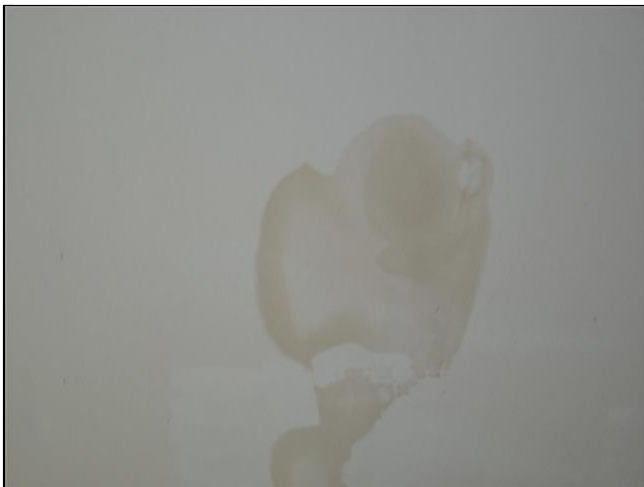
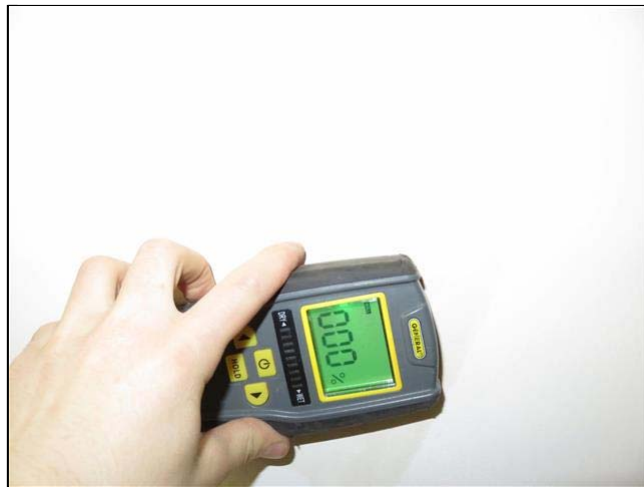
4.0 The Sheetrock on the ceiling at the living room in the basement reveals a light stain which appears from a water leak. Stain appears old and is dry. This is a cosmetic issue for your information.

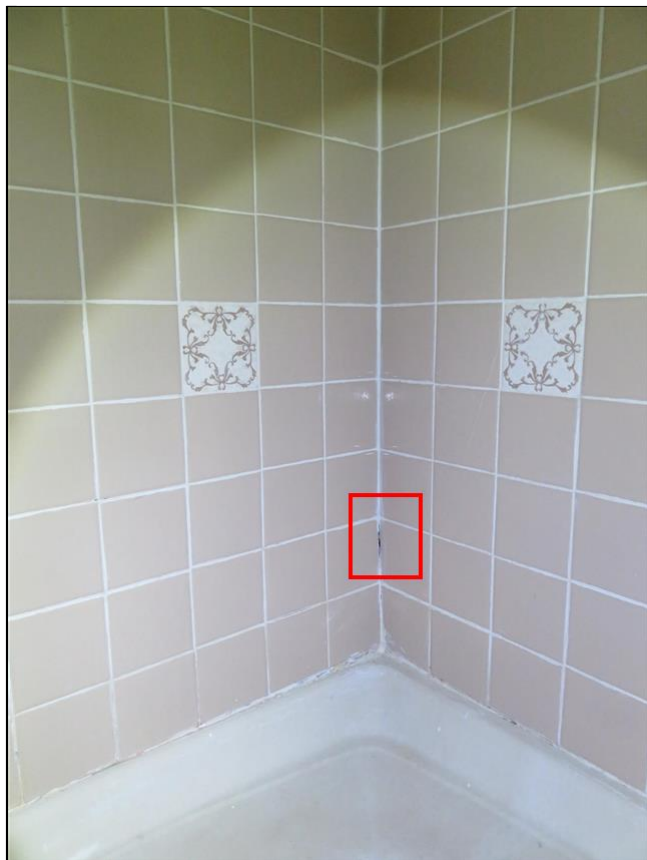
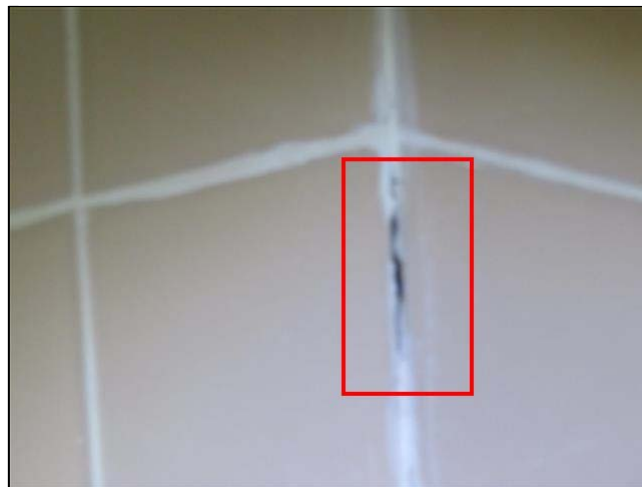
4.1 The Tile surround at shower on the wall has missing or loose grout at the master bath. This damage is considered cosmetic. A qualified person should repair or replace as needed.

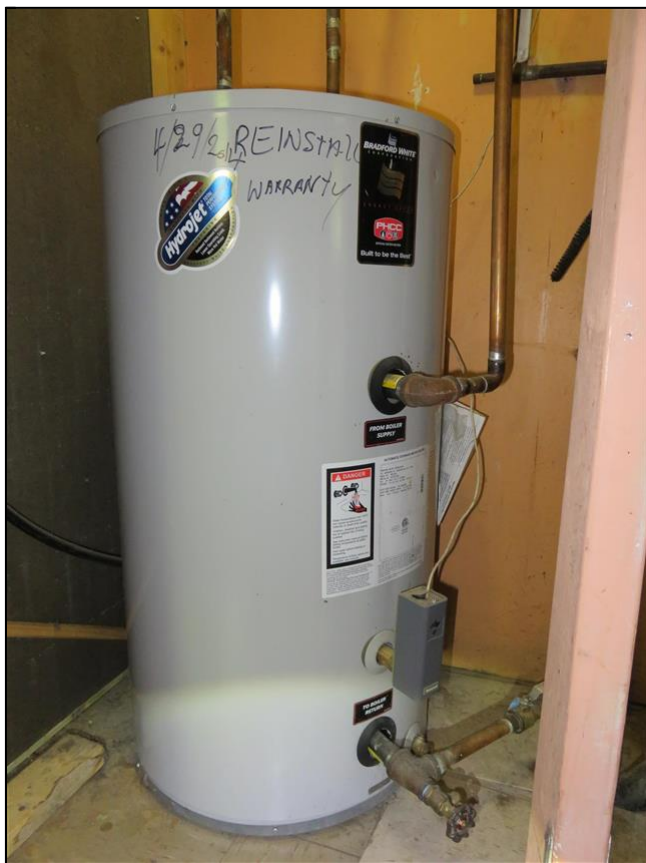
6.2 Hot water tank installation date: 04/29/2014

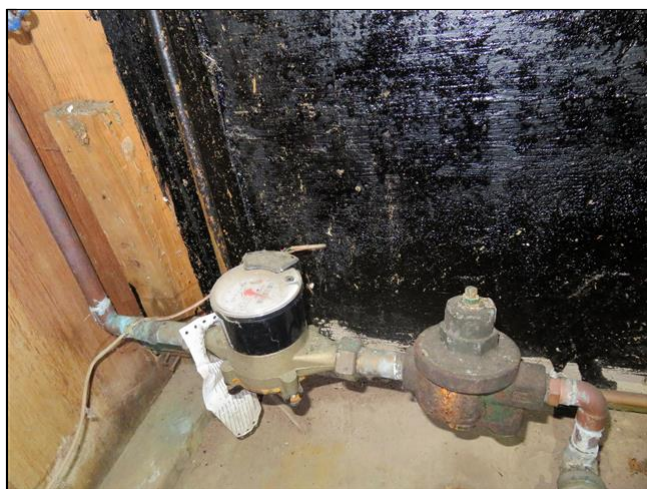
6.3 The main water shut off is located in the basement on the pipe near the water meter. This is for your information.

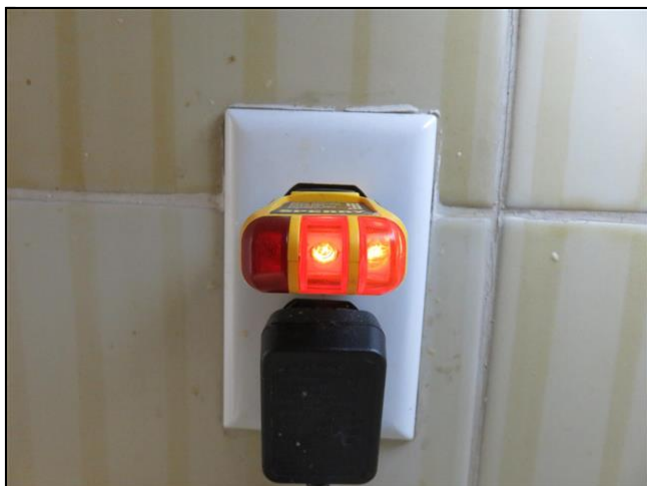
7.7 Outlets near the sinks are outdated and not a three-prong GFCI (Ground Fault Circuit Interrupt). Electrical issues are considered a hazard until repaired. A qualified licensed electrical contractor should correct as needed.

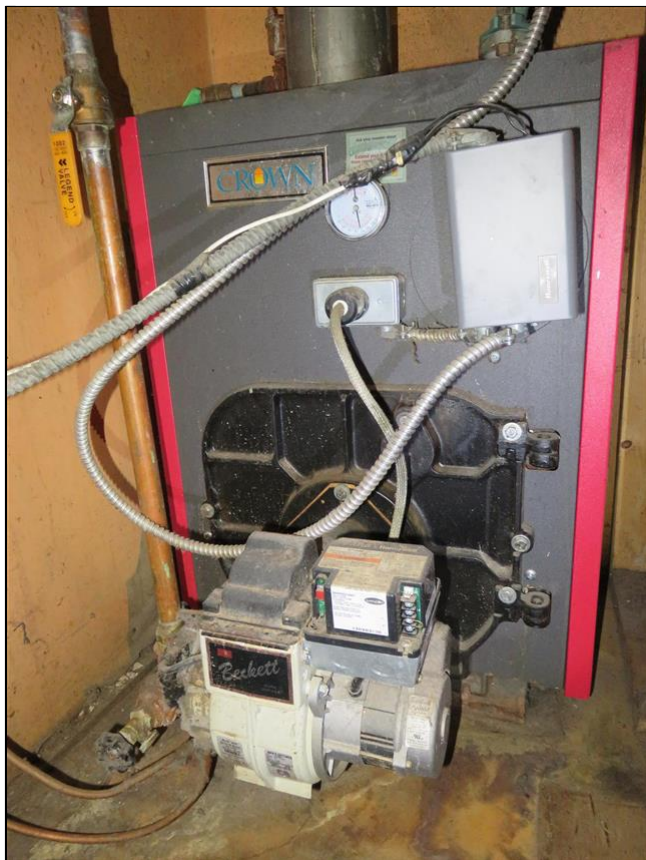
8.0 Forced air furnace manufactured 12/12/2005

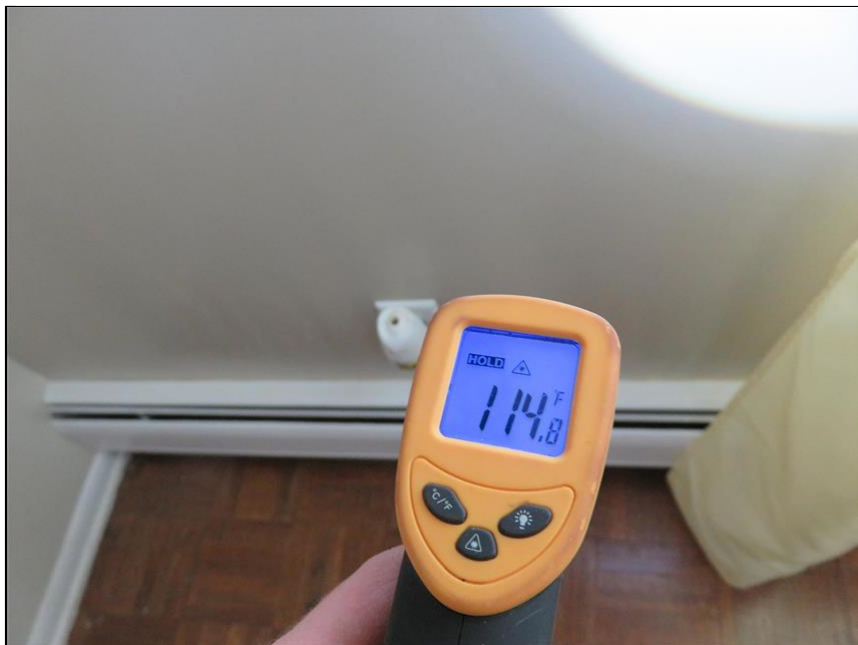
8.3 Heat reading 114F.

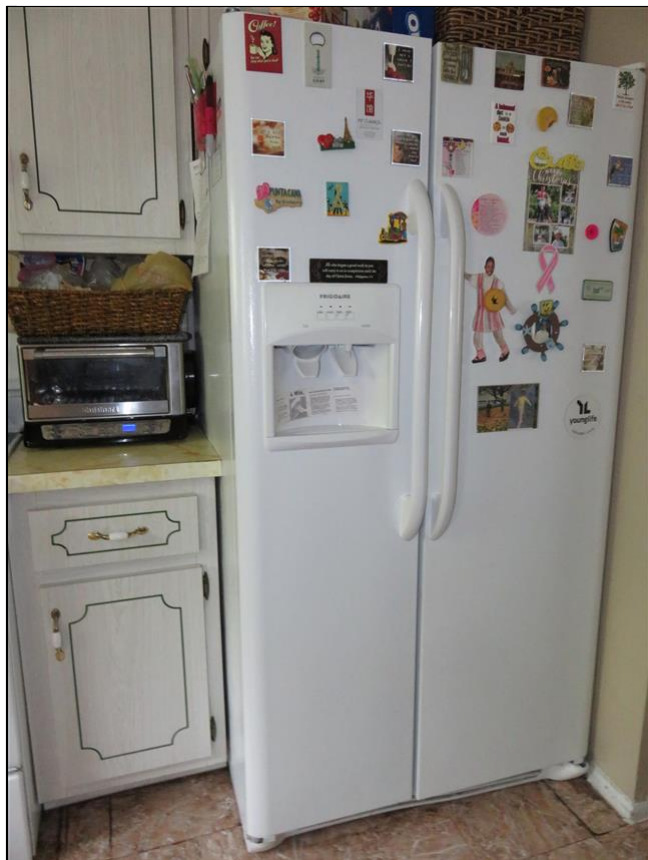
10.2 Refrigerator reading 43f, Freezer reading 24f

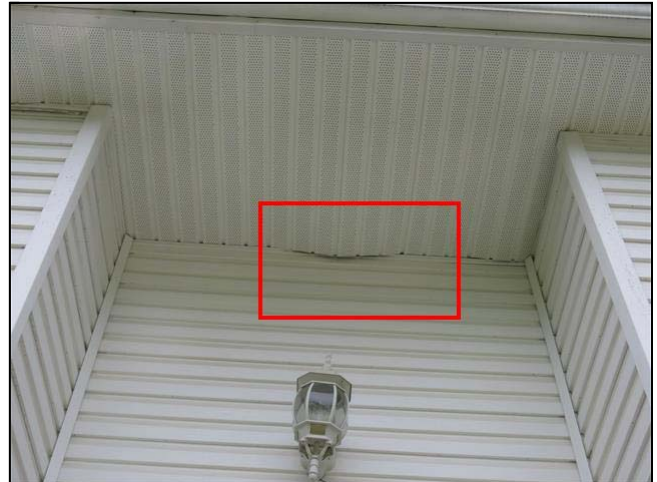
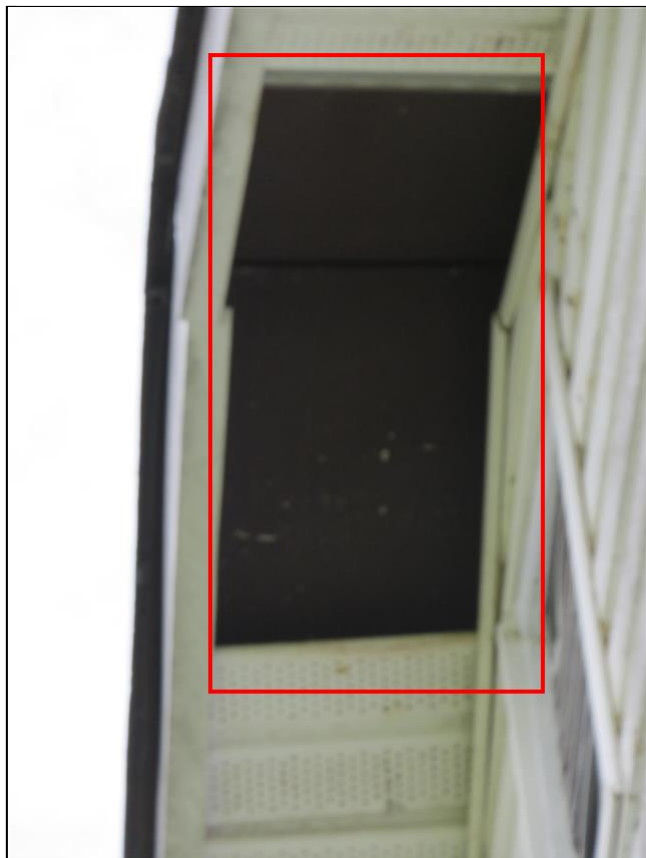
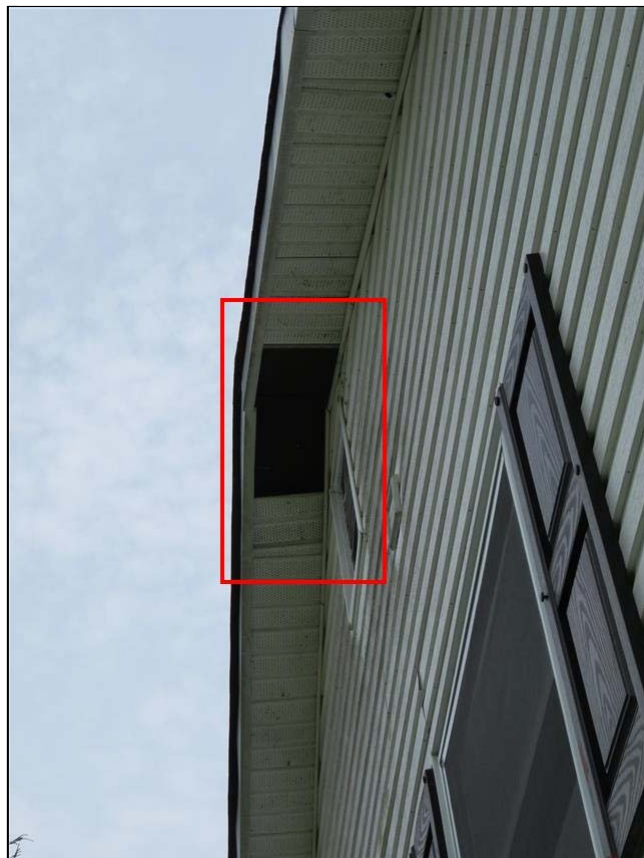
1.1

The side roof covering is loose and needs repair at the front, and right side (facing front). Deterioration may occur if not repaired. A qualified person should repair or replace as needed.

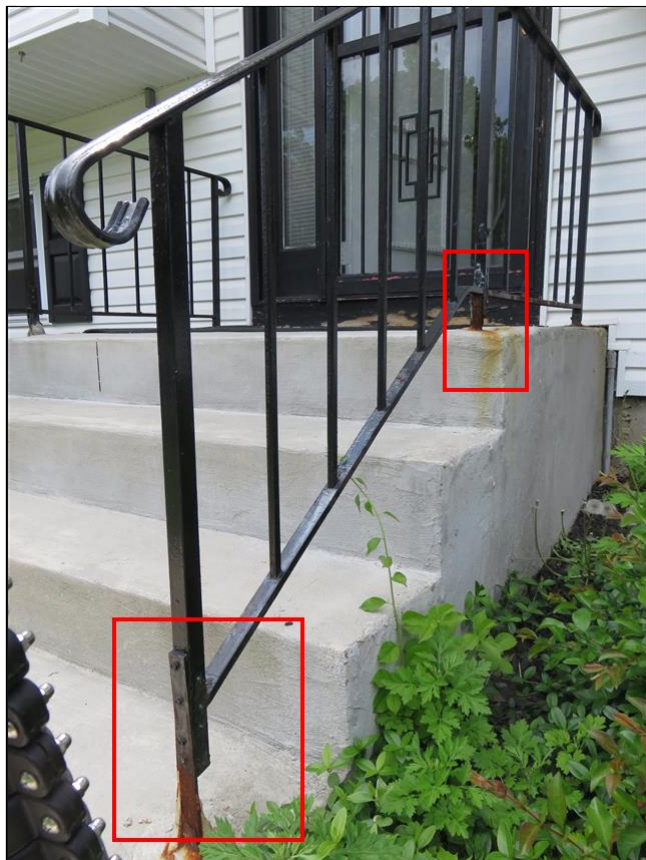
2.4

The hand/guard rail for the main entry is loose at the steps. This is a maintenance issue that can prevent further deterioration. A qualified contractor should repair or replace as needed.

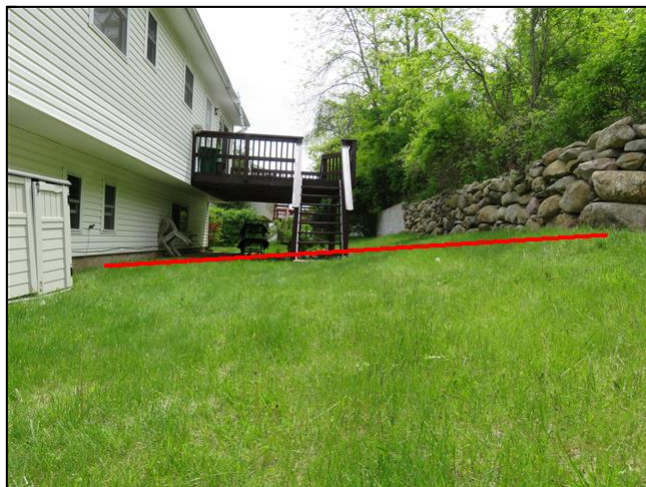
2.5

There is a negative slope towards the rear of home. This area does not appear to drain water away from home and needs landscaping and drainage corrected.

The moisture level on the wall behind the negative slope is elevated. A qualified licensed contractor should repair as needed.

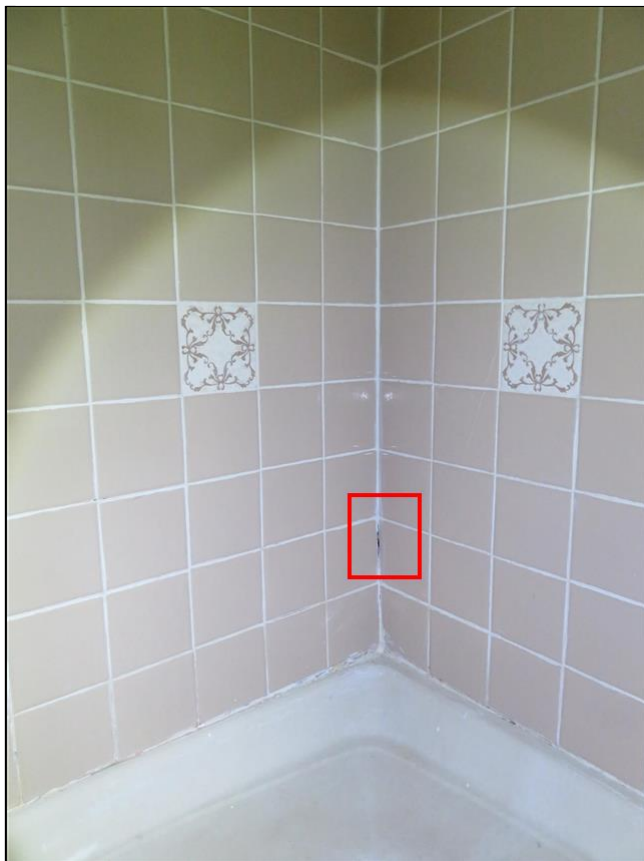
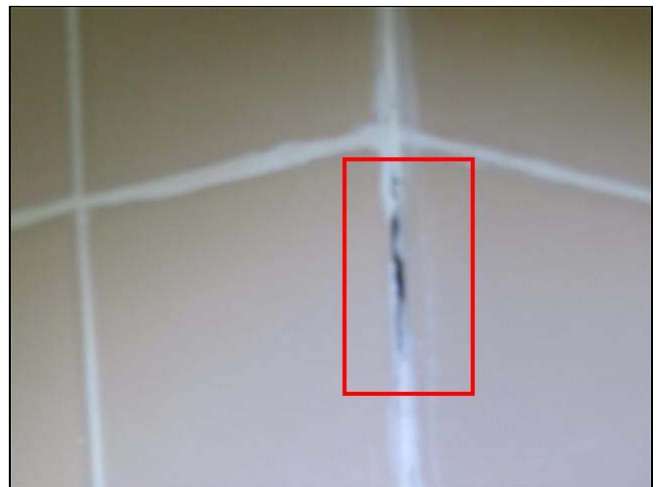
4.1

The Tile surround at shower on the wall has missing or loose grout at the master bath. This damage is considered cosmetic. A qualified person should repair or replace as needed.

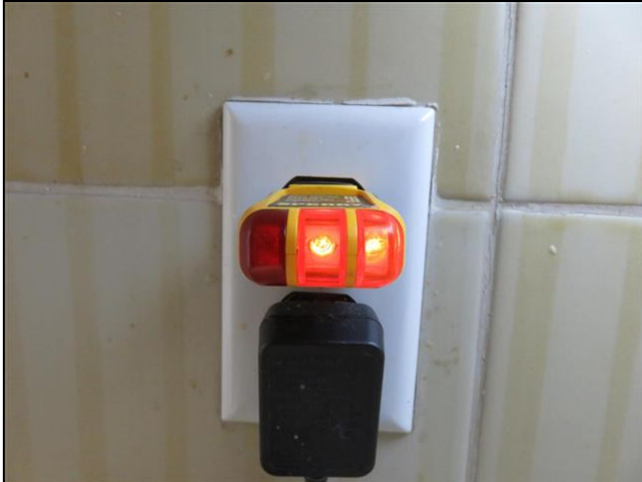
7.7

Outlets near the sinks are outdated and not a three-prong GFCI (Ground Fault Circuit Interrupt). Electrical issues are considered a hazard until repaired. A qualified licensed electrical contractor should correct as needed.
